A BETTER BOAT FOR YOUR MONEY

PART 2 NEW FOR OLD

In the second part of his description of a major refit of a second-hand Hallberg-Rassy 46, Leon Schulz gets down to the nitty-gritty of the work done and how much it all cost

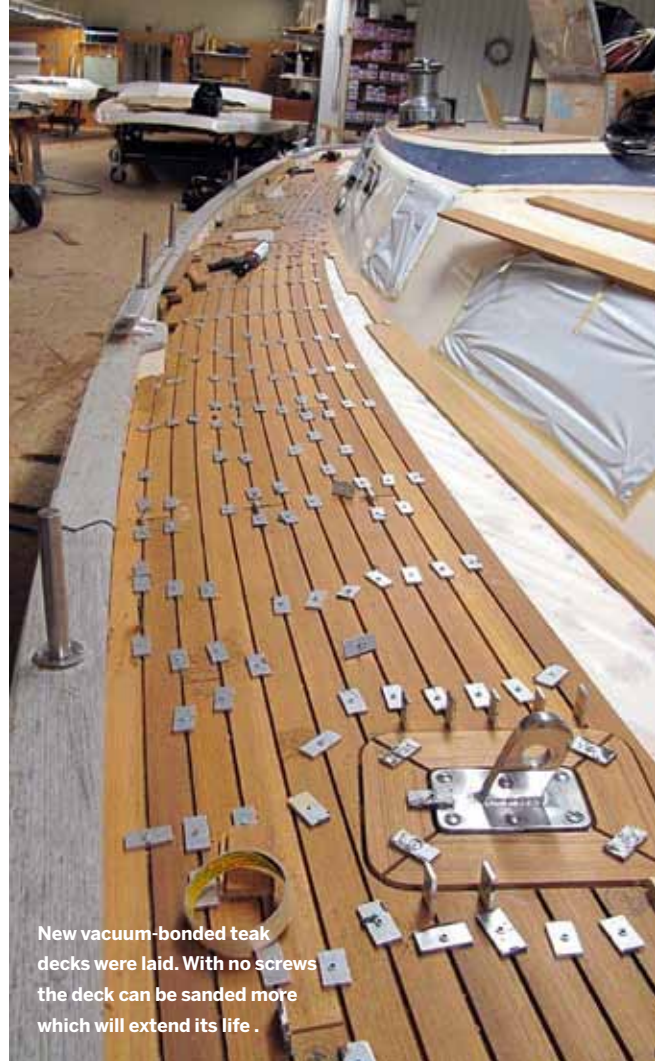
New vacuum-bonded teak decks were laid. With no screws the deck can be sanded more which will extend its life.

One of the biggest jobs was laying the new teak deck. Ellös Teakservice are specialists in laying vacuum-glued teak, which means that no screws are used. This keeps the deck 100 per cent watertight.

Traditional screwed teak is 12mm thick and after only 4mm of sanding the screws become visible. By exchanging and lowering each screw you can sand down another millimetre but this last effort is time-consuming and hard work.

Vacuum-glued teak is no more than 9mm thick. You not only save weight, but because of the lack of screws and a different design of the teak ribbons, you can sand down as much as 7mm. In other words, vacuum-glued teak has a considerably longer life span than screwed teak. Teak decks don't come cheap (€35,000), but it really does give the boat a facelift.

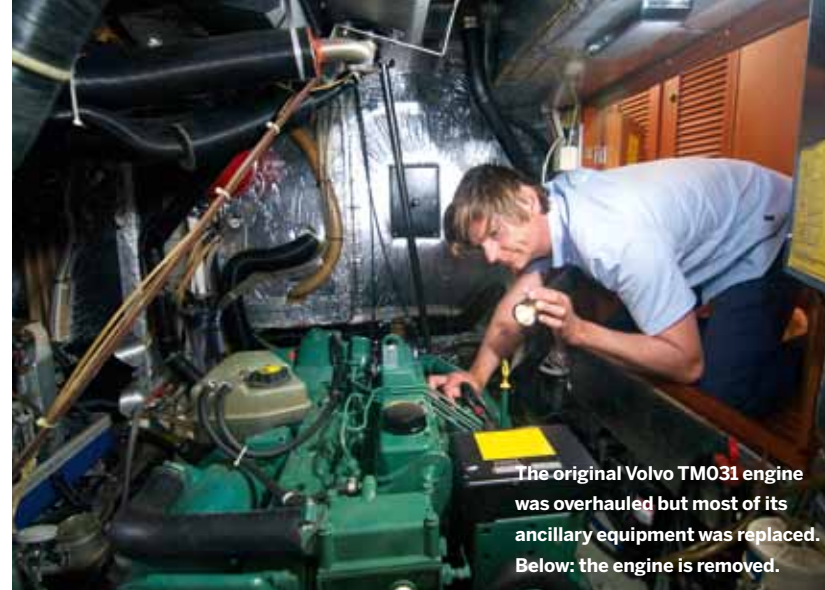
The original Volvo TMD31 engine was overhauled but most of its ancillary equipment was replaced. Below: the engine is removed.

The main engine was in good working order and, as it had relatively few engine hours we decided to keep the Volvo TMD31, but to replace everything else, including fitting a new diesel generator, a flexible coupling and replacing filters, pumps and pipes.

The Volvo was lifted out, washed, serviced and prepared for the reinstallation. A new SpeedSeal Life impeller kit was fitted, it acquired new rubber feet, a new silencer, new filters, Centaflex anti-vibration coupling, a new shaft seal, an external extra zinc anode and a rope cutter. Welding was needed to prepare it for the new 24V/110A High Output Alternator (HOA) by WhisperPower, allowing for full charging while running.

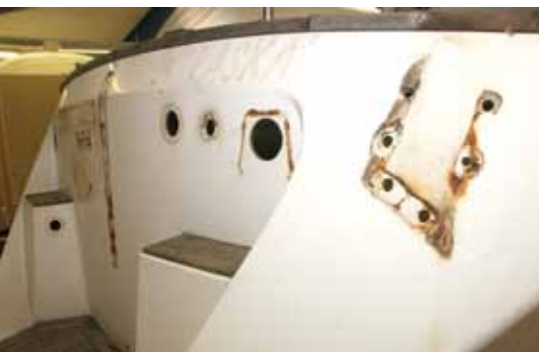
◀ Left: the condition of the stern was particularly poor which entailed removing and refitting everything including backstay chainplates. Above: it took 60 hours to re-polish the topsides. Right: re-varnishing and new lighting completely changed the ambience of the HR46's saloon.

Another issue that becomes visible after a dozen or so years is that the stern starts to fade compared with the rest of the hull and varies a little in colour. We decided to spray the stern. Last, but not least, the blue stripes along the waterline on *Regina Laska* needed to be repainted.
